**Flood Control Project Maintenance
Levee Inspections**

Maintenance Issue Types Only, Levee Inspection Report By Mile - Fall 2015

Reclamation District No. 0349 Sutter Island

Waterway	Bank	Unit Miles	Inspection Start/End	Inspector
Unit No. 01 Sacramento River	Right	1.59	10/09/2015 10/09/2015	Herman Phillips

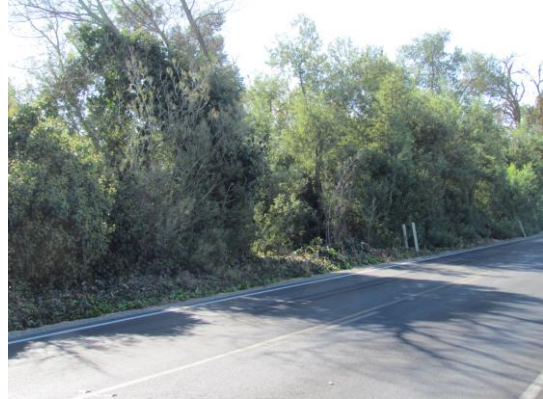
Photo 1 of 1 : FA_2015_RD0349_204_2_20151012_00010.jpg

LM Start	0.01	Rating **	U	Issue No.	2
LM End	0.75	Issue Type +	Ma	Location *	WS
Category	Earthen Levee			GPS Latitude/Longitude	
				Start	End
Item	Vegetation			38.327037 °	38.316518 °
				-121.576978 °	-121.579135 °
DWR ID	DWR_RD0349_01_f_2014_2				
Action/Comments					
Remove the wild growth other than native grasses from the levee slopes. Inspector Comments: This wild growth needs to be removed from the waterward levee shoulder and slope.

Unsatisfactory woody tree growth on the water side levee shoulder and slope

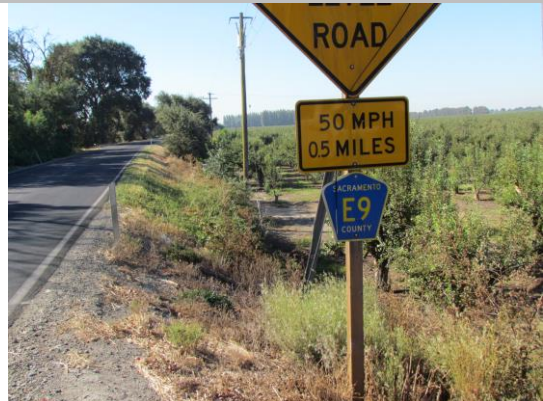
Photo 1 of 1 : FA_2015_RD0349_204_1_20151012_00011.jpg

LM Start	0.01	Rating **	U	Issue No.	1
LM End	0.97	Issue Type +	Ma	Location *	LS
Category	Earthen Levee			GPS Latitude/Longitude	
				Start	End
Item	Vegetation			38.327037 °	38.313367 °
				-121.576978 °	-121.578807 °
DWR ID	DWR_RD0349_01_f_2014_1				
Action/Comments					
Remove the wild growth other than native grasses from the levee slopes.					
Inspector Comments: Tall weeds need to be removed from levee section.

Unsatisfactory growth of wild weeds present on the landside levee slope and toe.

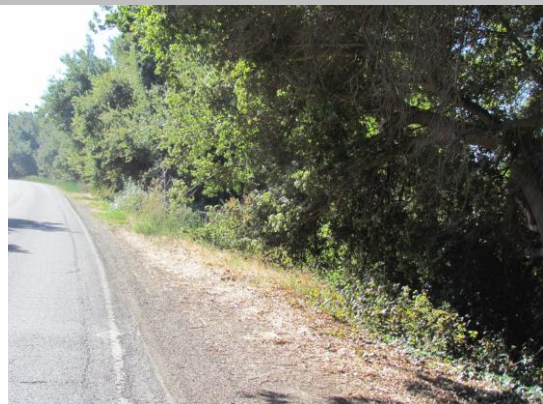
Photo 1 of 1 : FA_2015_RD0349_204_5_20151012_00016.jpg

LM Start	1.11	Rating **	U	Issue No.	5
LM End	1.27	Issue Type +	Ma	Location *	LS
Category	Earthen Levee			GPS Latitude/Longitude	
				Start	End
Item	Vegetation			38.311360 °	38.309287 °
				-121.578240 °	-121.577065 °
DWR ID	DWR_RD0349_01_f_2015_5				
Action/Comments					
Remove the wild growth other than native grasses from the levee slopes.					
Inspector Comments: The woody tree growth need to be removed and or thinned so the levee can be inspected.

Unsatisfactory woody tree growth blocking view of levee slope.

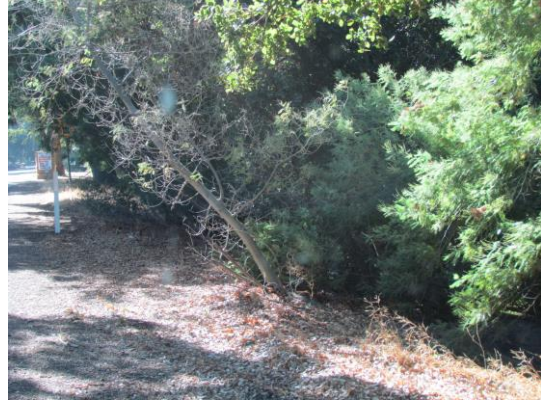
Photo 1 of 1 : FA_2015_RD0349_204_6_20151012_00015.jpg

LM Start	1.38	Rating **	U	Issue No.	6
LM End	1.41	Issue Type +	Ma	Location *	LS
Category	Earthen Levee			GPS Latitude/Longitude	
				Start	End
Item	Vegetation			38.307880 °	38.307453 °
				-121.576068 °	-121.575735 °
DWR ID	DWR_RD0349_01_f_2015_6				
Action/Comments					
Remove the wild growth other than native grasses from the levee slopes.					
Inspector Comments: Remove the woody tree growth from the landside levee slope and toe.

Unsatisfactory woody tree growth on the landside levee slope.

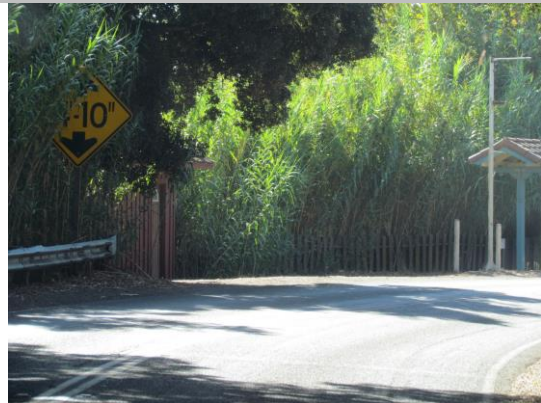
Photo 1 of 1 : FA_2015_RD0349_204_13_20151012_00014.jpg

LM Start	1.56	Rating **	U	Issue No.	13
LM End	1.58	Issue Type +	Ma	Location *	WS
Category	Earthen Levee			GPS Latitude/Longitude	
				Start	End
Item	Vegetation			38.305450 °	38.305162 °
				-121.574687 °	-121.574750 °
DWR ID	DWR_RD0349_01_f_2014_13				
Action/Comments					
Remove the wild growth other than native grasses from the levee slopes.					
Inspector Comments: This Arundo present on the waterward section is blocking the view of the levee section.

Unsatisfactory arundo completely covering the waterside shoulder and slope.

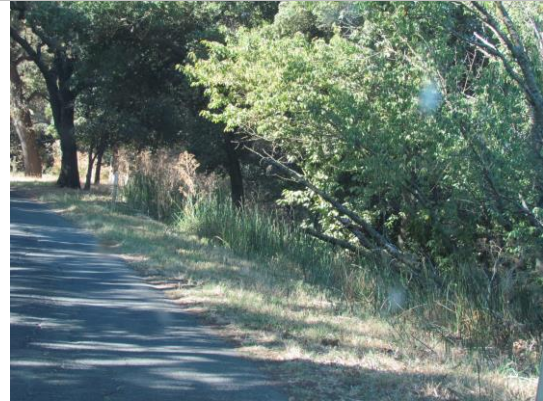
Photo 1 of 1 : FA_2015_RD0349_205_52_20151012_00051.jpg

Looking downstream from landside shoulder at tall snapgrass and other vegetation on slope.

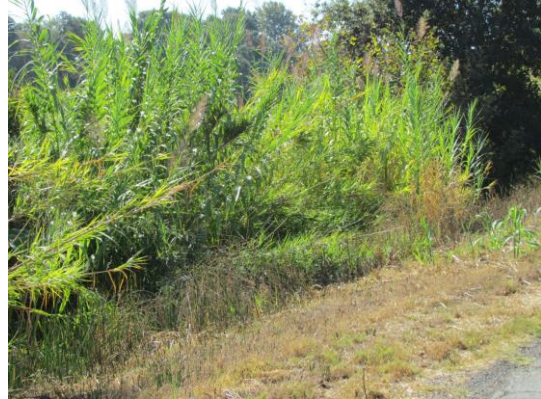
Photo 1 of 1 : FA_2015_RD0349_205_68_20151012_00054.jpg

Landside levee slope and toe covered with arundo.

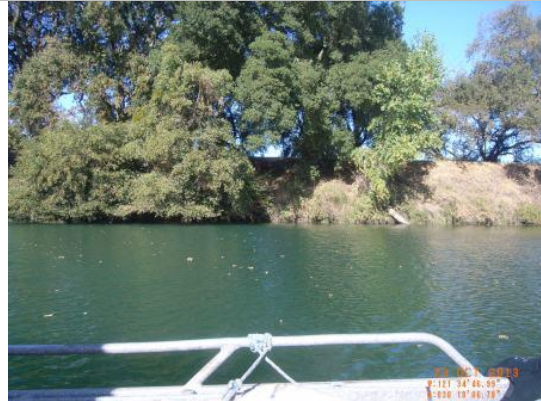
Photo 1 of 1 : USACE2013A_STM_25-8_R_2.jpg

LM Start	0.34	Rating **	M	Issue No.	9
LM End	0.39	Issue Type +	Ma	Location *	WS
Category	Supplemental			GPS Latitude/Longitude	
				Start	End
Item	2015 USACE Erosion Survey, DRAFT			38.302358 °	38.301772 °
				-121.579707 °	-121.580093 °
DWR ID					
Action/Comments					
Inspector Comments: 2007 - Slow erosion, probably due to wave wash and fluvial erosion. Site has likely been here for awhile but was unseen due to boats parked in front. 2015: Large tree popout, scarp reaches crown of levee. [2015 Site ID: STM_25-8_R]

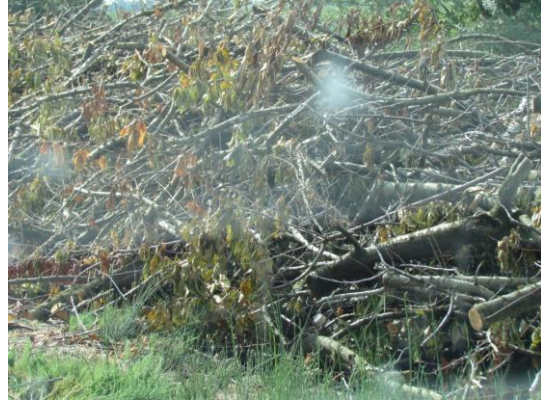
Photo 1 of 1 : FA_2015_RD0349_205_77_20150915_00027.jpg

LM Start	0.84	Rating **	U	Issue No.	77
LM End	0.96	Issue Type +	Ma	Location *	LS
Category	Earthen Levee			GPS Latitude/Longitude	
				Start	End
Item	Vegetation			38.295708 °	38.294014 °
				-121.582920 °	-121.583411 °
DWR ID	DWR_RD0349_02_s _ 2014_77				
Action/Comments					
Remove the wild growth other than native grasses from the levee slopes.					
Inspector Comments: This brush piled on the landward slope needs to be burned or removed. The metals in the pile will not burn.

Unwanted tree clippings piled on the slope creating a burn site. There are metals present in this brush pile.

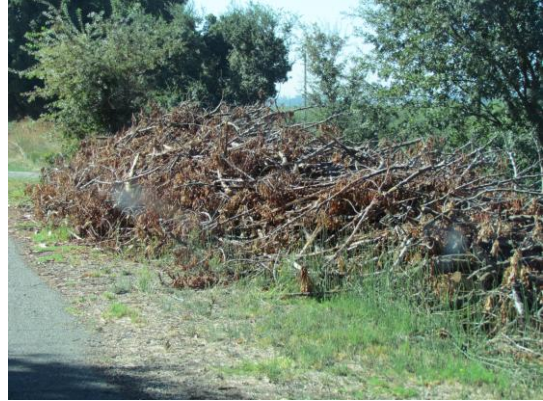
Photo 1 of 1 : FA_2015_RD0349_205_79_20151012_00055.jpg

LM Start	1.00	Rating **	U	Issue No.	79
LM End	1.06	Issue Type +	Ma	Location *	LS
Category	Earthen Levee			GPS Latitude/Longitude	
				Start	End
Item	Slope Stability			38.293383 °	38.292592 °
				-121.583570 °	-121.583861 °
DWR ID	DWR_RD0349_02_s_2014_79				
Action/Comments					
Repair slope instability. Inspector Comments: There is some erosion present under this brush pile The district needs to bring in some material to make repairs as needed.

Under the brush pile is some erosion along the landside slope.

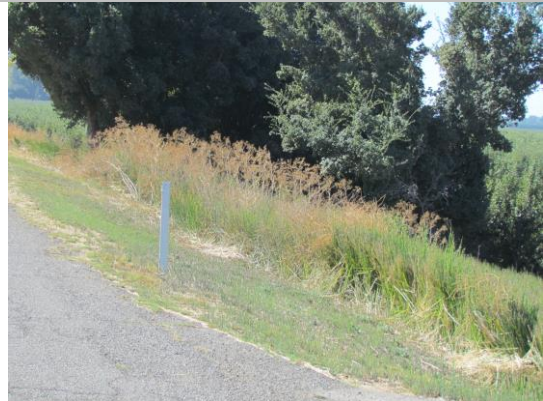
Photo 1 of 1 : FA_2015_RD0349_205_14_20151012_00060.jpg

LM Start	1.07	Rating **	U	Issue No.	14
LM End	1.30	Issue Type +	Ma	Location *	LS
Category	Earthen Levee			GPS Latitude/Longitude	
				Start	End
Item	Vegetation			38.292457 °	38.289063 °
				-121.583898 °	-121.584057 °
DWR ID	DWR_RD0349_02_f_2015_14				
Action/Comments					
Control annual grass and weeds on the levee slopes and easements. Inspector Comments: Remove the snap grass from the landward slope.

Looking downstream from levee mile 1.07 to 1.30 snap grasses covering landward slope.

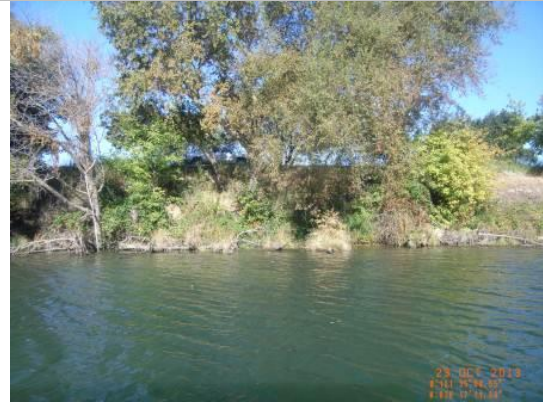
Photo 1 of 1 : USACE2013A_STM_24-7_R_2.jpg

Inspector Comments: 1997 - Erosion of very sandy levee behind large stand of riparian vegetation on top right bank. Dry ravel of sand. 1999 - Quarry waste rock was dumped down the levee slope; poor repair job; still eroding in places. Eroding at midslope off fabric. 2005 - Length revised, only the middle 150 - 200 ft are eroding. 2006 - Some rock/small material dumped down the bank but it is slowly unraveling. Upstream end is unraveling faster. Steep slope with poor gradation so fines are washing out. 2010 - Lots of overhanging trees and erosion pockets. 2011 - This site is upgraded to CRITICAL. Near vertical bank at the downstream end. New erosion at various locations throughout the site. 2015: No observed changes. [2015 Site ID: STM_24-7_R]

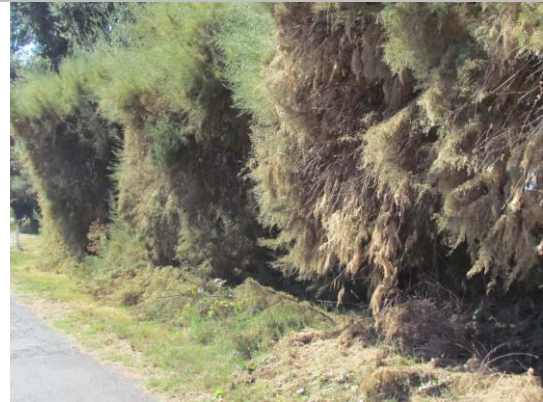
Photo 1 of 1 : FA_2015_RD0349_205_61_20151012_00057.jpg

LM Start	1.33	Rating **	U	Issue No.	61
LM End	1.35	Issue Type +	Ma	Location *	LS
Category	Earthen Levee			GPS Latitude/Longitude	
				Start	End
Item	Vegetation			38.288717 °	38.288467 °
				-121.584038 °	-121.584070 °
DWR ID	DWR_RD0349_02_f_2015_61

Looking downstream from levee mile 1.33-1.35 woody tree growth completely blocking the view of the levee.

Inspector Comments: Remove the woody tree growth from the levee slope and shoulder.

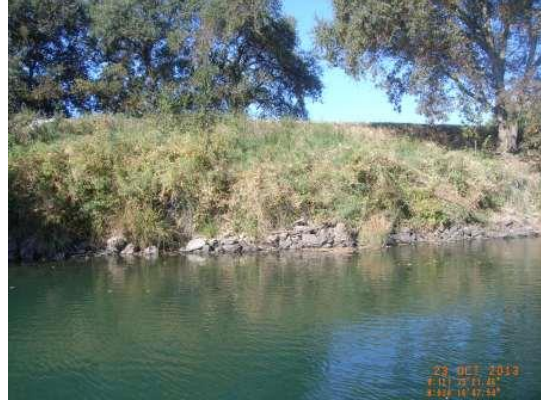
Photo 1 of 1 : USACE2013A_STM_24-1_R_1.jpg

LM Start	2.04	Rating **	M	Issue No.	19
LM End	2.05	Issue Type +	Ma	Location *	WS
Category	Supplemental			GPS Latitude/Longitude	
				Start	End
Item	2015 USACE Erosion Survey, DRAFT			38.280069 °	38.279919 °
				-121.589443 °	-121.589438 °
DWR ID					
Action/Comments					
Inspector Comments: 2011 - Small scallop caused by erosion and wave wash. 2015: No observed changes. [2015 Site ID: STM_24-1_R]

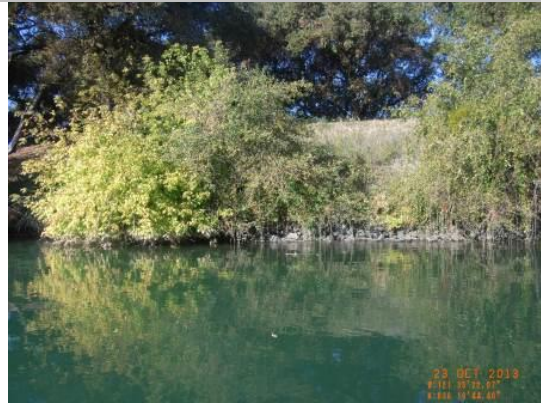
Photo 1 of 1 : USACE2013A_STM_23-9_R_5.jpg

LM Start	2.11	Rating **	M	Issue No.	16
LM End	2.14	Issue Type +	Ma	Location *	WS
Category	Supplemental			GPS Latitude/Longitude	
				Start	End
Item	2015 USACE Erosion Survey, DRAFT			38.279017 °	38.278597 °
				-121.589615 °	-121.589854 °
DWR ID					
Action/Comments					
Inspector Comments: 1997 - Top right bank has retreated into the levee. Site is between two rock sites. 1999 - Downstream half of the reach repaired with rock. 2000 - Trees leaning into the water. 2010 - Site appears worse. 2011 - New erosion at the toe. 2013 - Short vertical sections observed at upstream end. 2015: Minor new erosion. [2015 Site ID: STM_23-9_R]

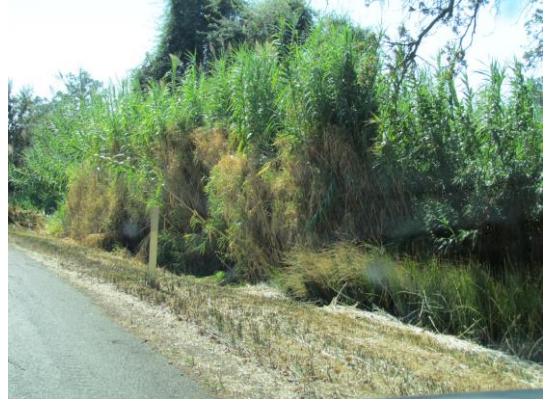
Photo 1 of 1 : FA_2015_RD0349_205_75_20151012_00053.jpg

Looking downstream from levee mile 2.37-2.40 arundo has completely covered the landward levee section

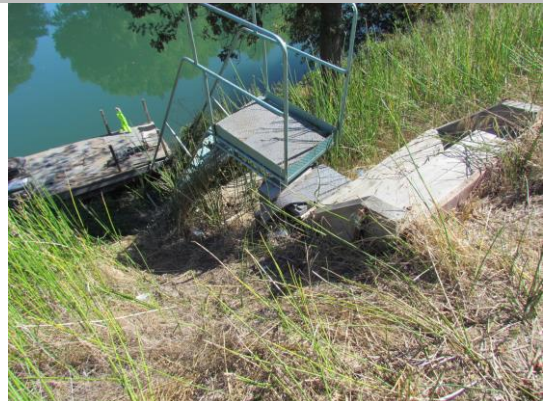
Photo 1 of 2 : FA_2015_RD0349_205_1_20151012_00058.jpg

LM Start	2.39	Rating **	U	Issue No.	1
LM End	2.39	Issue Type +	Ma	Location *	WS
Category	Earthen Levee			GPS Latitude/Longitude	
				Start	End
Item	Encroachments			38.275403 °	38.275403 °
				-121.591229 °	-121.591229 °
DWR ID	DWR_RD0349_02_f_2013_1				
Action/Comments					
Stairway Inspector Comments: The landowner has installed steps on the waterside slope and has an unauthorized boat dock anchored to the waterside slope.

Unauthorized steps placed on the waterward levee slope.

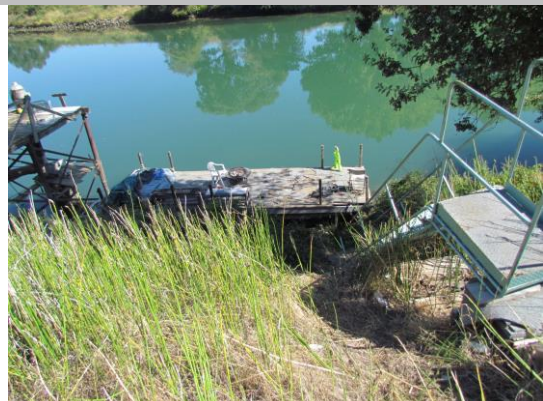
Photo 2 of 2 : FA_2015_RD0349_205_1_20151012_00059.jpg

Unauthorized boat dock remains on the waterward toe.

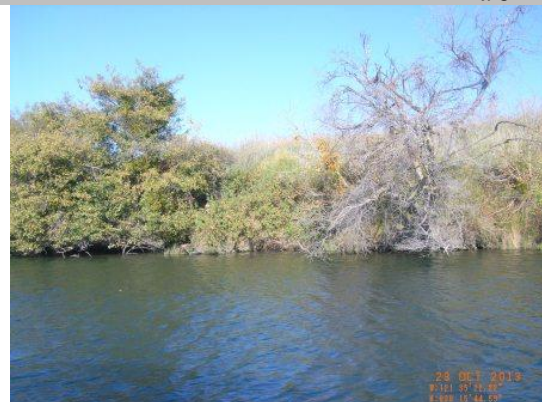
Photo 1 of 1 : USACE2013A_STM_22-8_R_6.jpg

LM Start	3.38	Rating **	M	Issue No.	11
LM End	3.49	Issue Type +	Ma	Location *	WS
Category	Supplemental			GPS Latitude/Longitude	
				Start	End
Item	2015 USACE Erosion Survey, DRAFT			38.262510 °	38.262533 °
				-121.589481 °	-121.591690 °
DWR ID					
Action/Comments					
Inspector Comments: 2010 - Slumping sections on the lower bank, appears to be scouring around the trees. 2011 - Soil beach at toe. 2015: No observed changes. [2015 Site ID: STM_22-8_R]

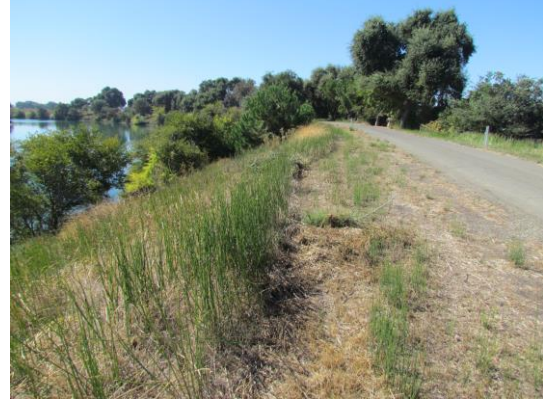
Photo 1 of 1 : FA_2015_RD0349_205_84_20151012_00062.jpg

Tall snap grasses covering the waterward slope.

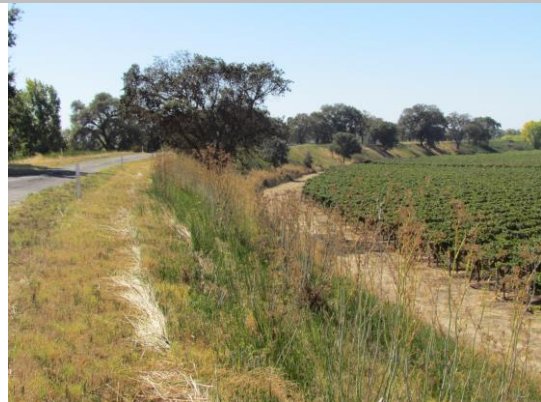
Photo 1 of 1 : FA_2015_RD0349_205_87_20151012_00066.jpg

Unsatisfactory tall snap grasses and sweet anise weeds on landside slope.

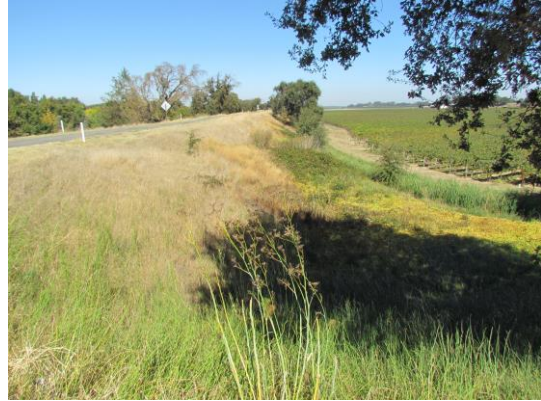
Photo 1 of 1 : FA_2015_RD0349_206_51_20151012_00040.jpg

Looking downstream from levee mile 0.00 to levee mile 1.53 landside slope covered with tall weeds and berries.

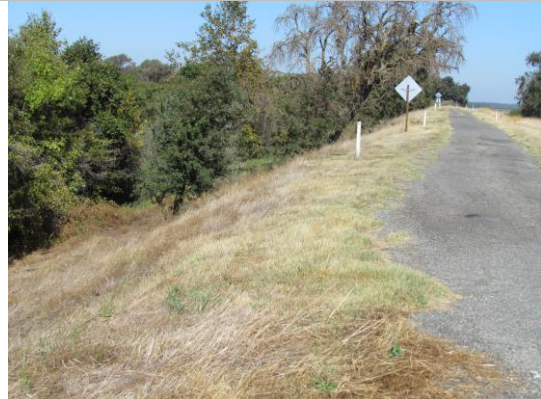
Photo 1 of 1 : FA_2015_RD0349_206_1_20151012_00038.jpg

LM Start	0.03	Rating **	U	Issue No.	1
LM End	1.16	Issue Type +	Ma	Location *	WS
Category	Earthen Levee			GPS Latitude/Longitude	
				Start	End
Item	Vegetation			38.255094 °	38.271075 °
				-121.600101 °	-121.603527 °
DWR ID	DWR_RD0349_03_s_2013_1				
Action/Comments					
Remove the wild growth other than native grasses from the levee slopes.					
Inspector Comments: Mow the waterside levee slope.

Looking downstream from levee mile 0.00 waterside.

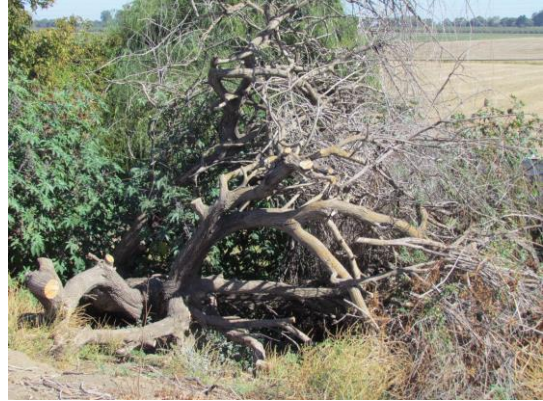
Photo 1 of 1 : FA_2015_RD0349_206_971_20151012_00043.jpg

The dead tree listed in last inspection has not been completely removed, nor has the woody tree growth been thinned out.

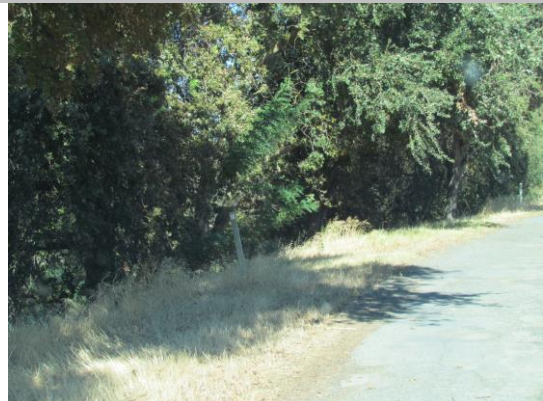
Photo 1 of 1 : FA_2015_RD0349_206_54_20151012_00044.jpg

LM Start	1.22	Rating **	U	Issue No.	54
LM End	1.69	Issue Type +	Ma	Location *	WS
Category	Earthen Levee			GPS Latitude/Longitude	
				Start	End
Item	Vegetation			38.271910 °	38.278318 °
				-121.603358 °	-121.600343 °
DWR ID	DWR_RD0349_03_f _ 2015_54				
Action/Comments					
Control annual grass and weeds on the levee slopes and easements. Inspector Comments: Remove the unwanted woody tree growth from the waterside levee section.

Looking downstream from the waterside levee shoulder and slope woody tree growth blocking the view of the levee section.

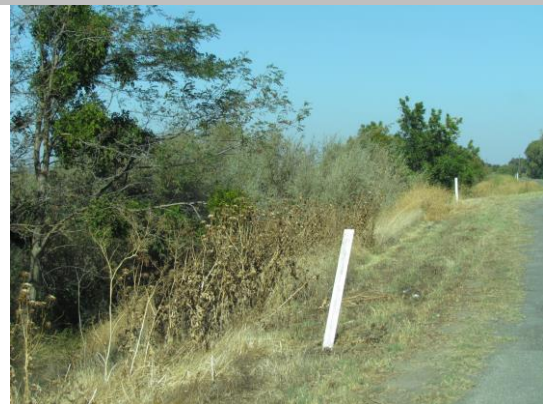
Photo 1 of 1 : FA_2015_RD0349_206_67_20151012_00045.jpg

Looking downstream waterside shoulder and slope at unsatisfactory tall weeds blocking the view of the levee section.

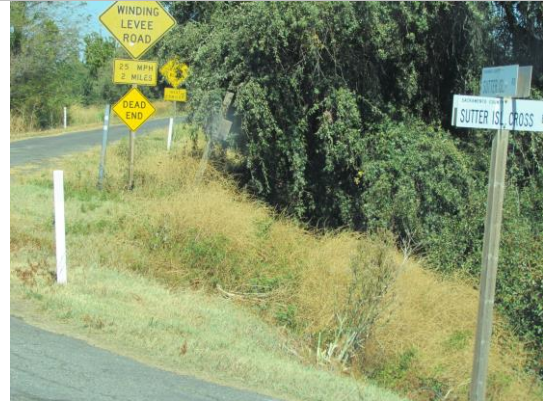
Photo 1 of 1 : FA_2015_RD0349_206_72_20151009_00037.jpg

Unsatisfactory tall weeds and vegetation on the landside levee slope and shoulder

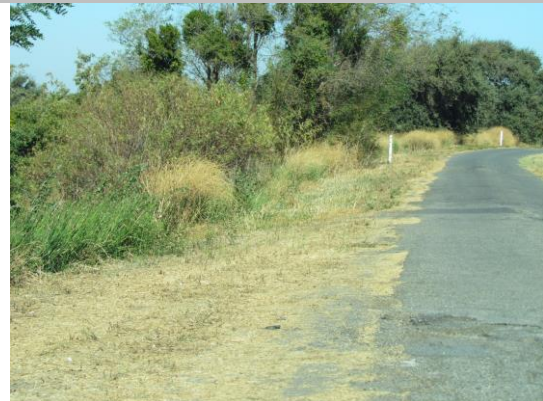
Photo 1 of 1 : FA_2015_RD0349_206_74_20151012_00046.jpg

LM Start	3.01	Rating **	U	Issue No.	74
LM End	6.50	Issue Type +	Ma	Location *	WS
Category	Earthen Levee			GPS Latitude/Longitude	
				Start	End
Item	Vegetation			38.296030 °	38.327002 °
				-121.604710 °	-121.576920 °
DWR ID	DWR_RD0349_03_f_2015_74				
Action/Comments					
Control annual grass and weeds on the levee slopes and easements. Inspector Comments: Looking downstream from the waterside levee slope at unsatisfactory vegetation.

Looking downstream waterside, unsatisfactory tall vegetation blocking view of the levee slope.

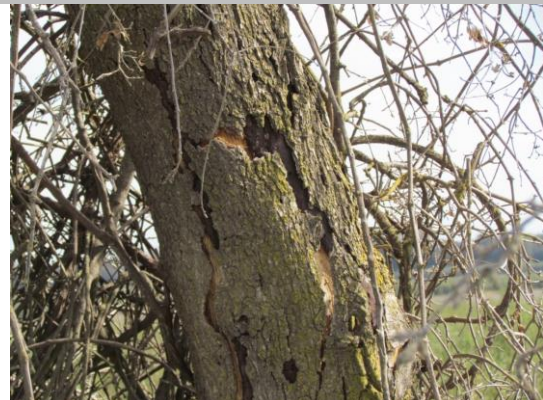
Photo 1 of 2 : FA_2015_RD0349_206_73_20150915_00012.jpg

LM Start	3.19	Rating **	U	Issue No.	73
LM End	3.19	Issue Type +	Ma	Location *	LS
Category	Earthen Levee			GPS Latitude/Longitude	
				Start	End
Item	Trim / Thin Trees			38.298223 °	38.298223 °
				-121.603240 °	-121.603240 °
DWR ID	DWR_RD0349_03_f_2014_73				
Action/Comments					
Trim trees over roadway to at least 12 feet above ground level. Inspector Comments: This tree on the landside slope is rotten and could possibly fall across levee section.

Close up view of dead tree standing above crown roadway.

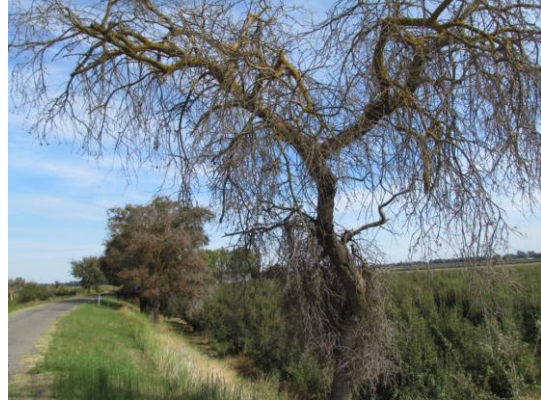
Photo 2 of 2 : FA_2015_RD0349_206_73_20150915_00013.jpg

Dead tree above crown roadway landward.

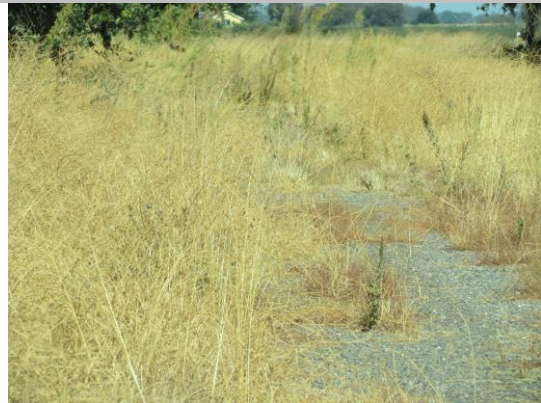
Photo 1 of 1 : FA_2015_RD0349_206_80_20151009_00036.jpg

LM Start	4.74	Rating **	U	Issue No.	80
LM End	6.30	Issue Type +	Ma	Location *	CR
Category	Earthen Levee			GPS Latitude/Longitude	
				Start	End
Item	Vegetation			38.316183 °	38.329088 °
				-121.590735 °	-121.579400 °
DWR ID	DWR_RD0349_03_f_2015_80				
Action/Comments					
Keep the crown roadway free of vegetation. Inspector Comments: Unable to continue from this point, the vegetation growth present on crown road way presented an extreme fire hazard to vehicles equipped with catalytic converter

RD 349 Levee mile 4.74 looking at overgrown crown roadway. Weeds are taller than four feet. Extreme fire hazard.
